## Axis3D AMO – stand alone, flexible monitoring

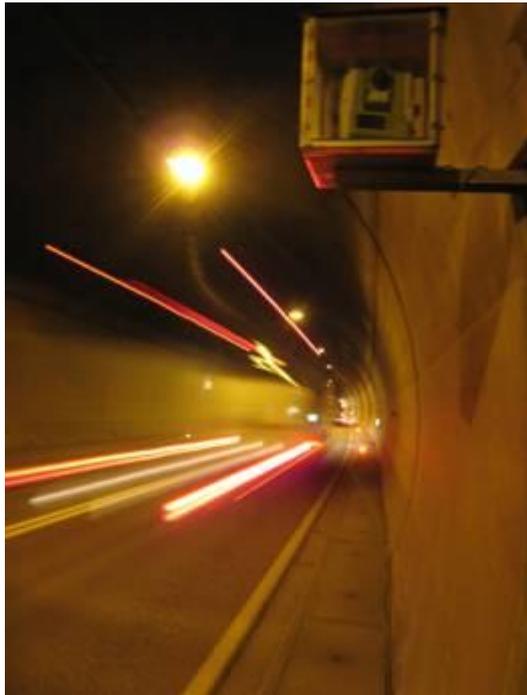
A Leica TCA1201 total station equipped with Axis3D AMO was installed in the tunnel and connected to the engineering office via GPRS for remote communication. Axis3D AMO has been measuring all 46 defined deformation points continuously every two hours since its installation in 2008, calculating point coordinates using current refraction conditions in the tunnel. In spring 2009 the measured deformation exceeded the allowed monitoring limits and the tunnel tubes were closed before traffic safety was compromised. The damages were then repaired so the tunnels could be re-opened to traffic.

When a landslide threatened to damage the dual tube highway tunnel Niklasdorf, the owner was forced to act. Automatic three-dimensional monitoring of the most affected areas of the tunnel was chosen to ensure continued traffic safety. A stable and immediately available system was needed that would not hinder traffic flow and that could withstand the harsh conditions in the tunnel (dirt, water) for years to come.

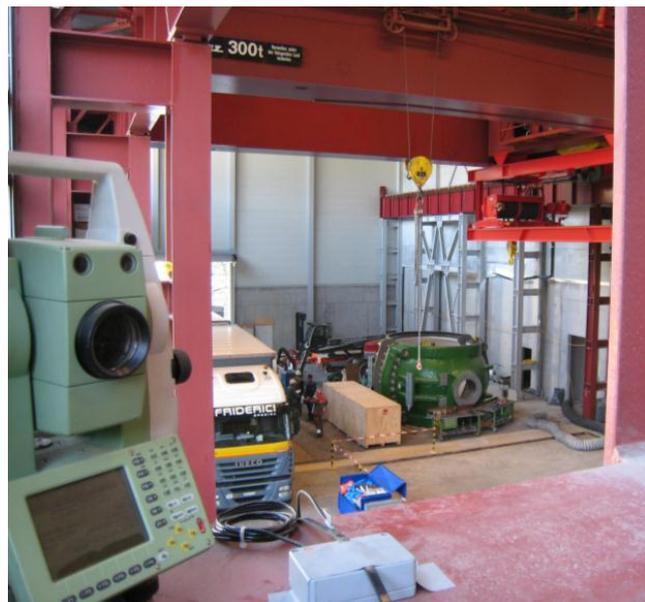
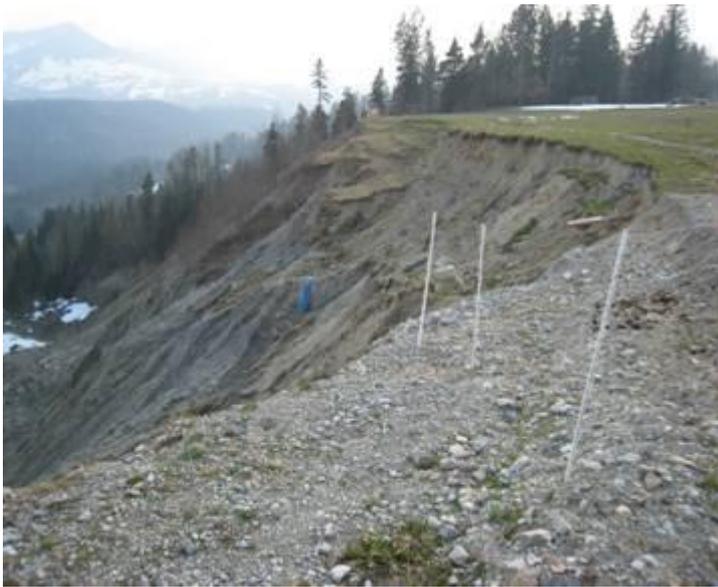
Axis3D AMO was up and running within a mere four hours, including test runs; the actual set up took just one hour. Since its installation, Axis3D AMO has been measuring sets to 21 targets continuously every four minutes. Results are displayed on a screen in the assembly hall in real-time, allowing instantaneous reactions should any changes occur.

Due to settlement of an assembly hall, the owner, a power plant operator, was concerned about track deformations of the hall's 300-ton crane. A system for three-dimensional monitoring of the crane supports, in particular of changes in track gauge and vertical displacement of the crane tracks, was needed.
